**US Army Corps of Engineers
Washington Aqueduct
Castle Gatehouse
Cultural Resources and Consultation Summary Report
16 August 2024**

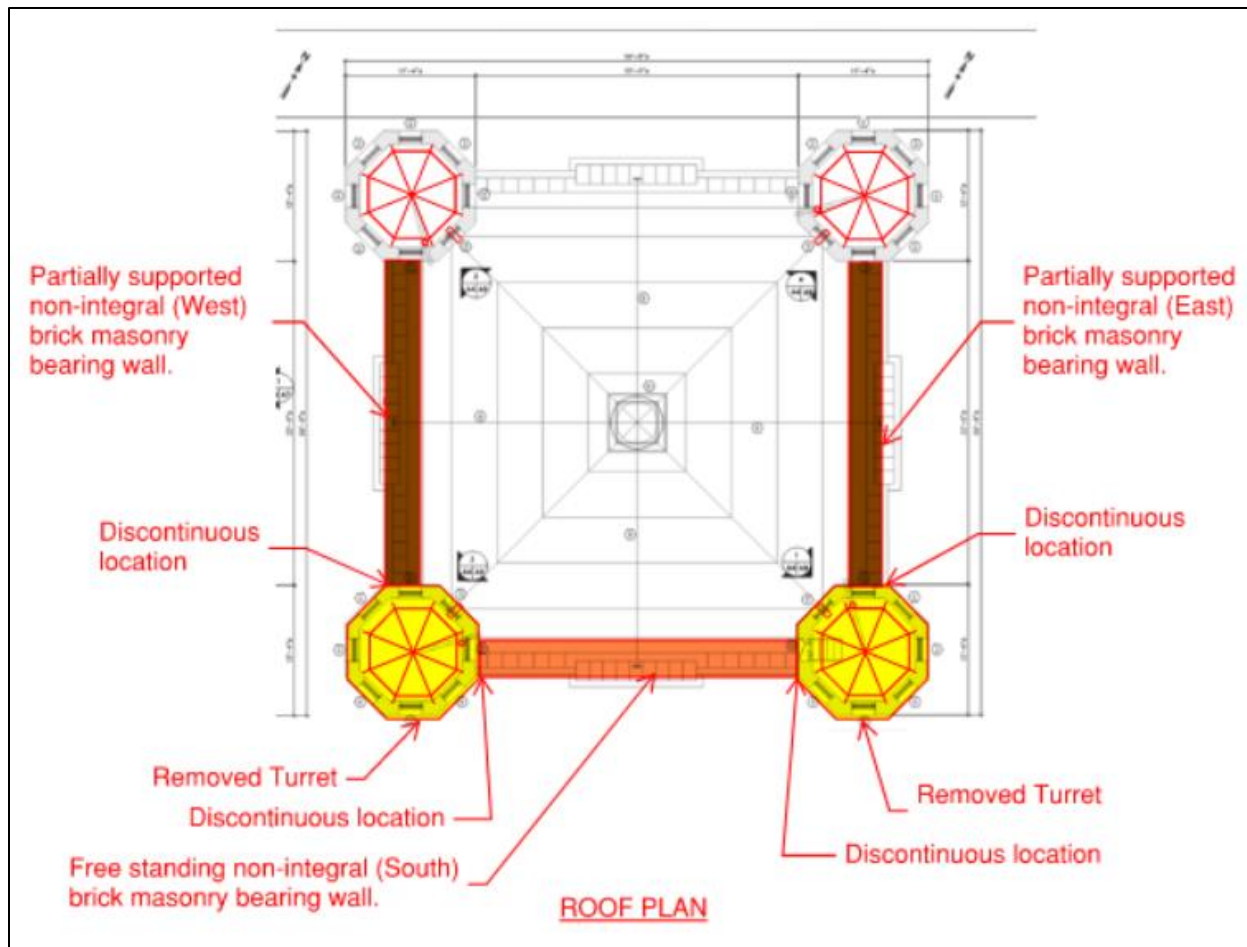
The larger structural concern is the global stability of the structure and the observed lateral load path interruptions. Now that two of the four turrets have been demolished, the local stability of three of the four walls is in jeopardy and the global stability of the structure is compromised. The south wall is acting as a free-standing wall due to the removal of the southeast and southwest corner turrets. These turrets acted as the structural intersections with the east and west walls and the east and west supports. Without these supports, this wall cannot transfer lateral loads to the building system and is therefore resisting loads that would normally be transferred safely to other elements. The wall itself is not designed for, and is not capable of, resisting such loads without damage and eventual collapse. The east and west walls have similar stability concerns as they do not have the means to transfer lateral loads in the east-west direction into the southern wall, adding additional stress to the system without a clear load path to the southern wall. In the current condition, the east and west wall load path is approximately twice as long as it was when the turrets were whole. The loss of continuity amplifies structural stresses and deflections. In the event of any wind storm or seismic activity the discontinuity and stability issues will result in cracking and other damage throughout the masonry structure and could result in catastrophic failure including collapse.

The current situation at the Castle Gatehouse requires immediate action to prevent unintended adverse effects on the historic structure that will result from any lateral loading that occurs while the two southern turrets are in their current demolished condition. The demolished condition dramatically interrupts the structural lateral system. Any significant wind or seismic load on the structure, such as from a severe thunderstorm, tropical storm or hurricane, or an earthquake of any magnitude will result in unintended movement throughout the remaining masonry structure. The result of such movement is deflection and cracking of the remaining walls and turrets, some of which could be catastrophic.

It is critical from a structural perspective that the continuity and structural integrity of the masonry system be reestablished by reconstructing the turrets and therefore restoring the structural stability of the overall building system. Additionally, localized or complete structural collapse will result in a complete outage of the McMillan WTP. The water storage capacity at the existing McMillan WTP clearwells is not adequate to cover an outage beyond a few hours of duration and will create interruption to the critical water supply for Washington DC and parts of Northern Virginia. The Government proposes to reconstruct the two demolished southern turrets using appropriate materials and methods with in kind materials, matching the footprint, portions, design, and appearance of what was removed.
